Ref Tree Condition Survey Hartlebury Parish Hall

## Tree Condition Survey

Name of Estate: Hartlebury Parish Hall

Date: 27/05/2022

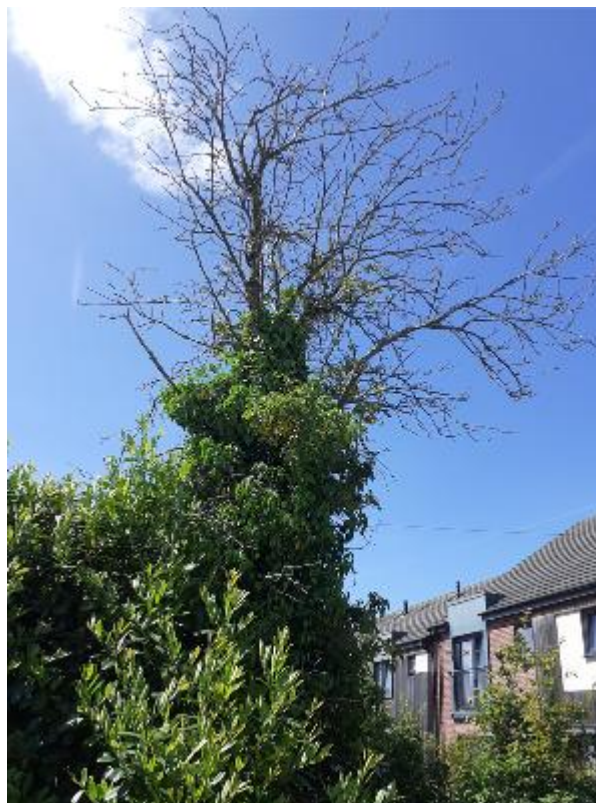
5.1 T2456 is a Wych Elm which has contracted Dutch Elm disease and requires removal.

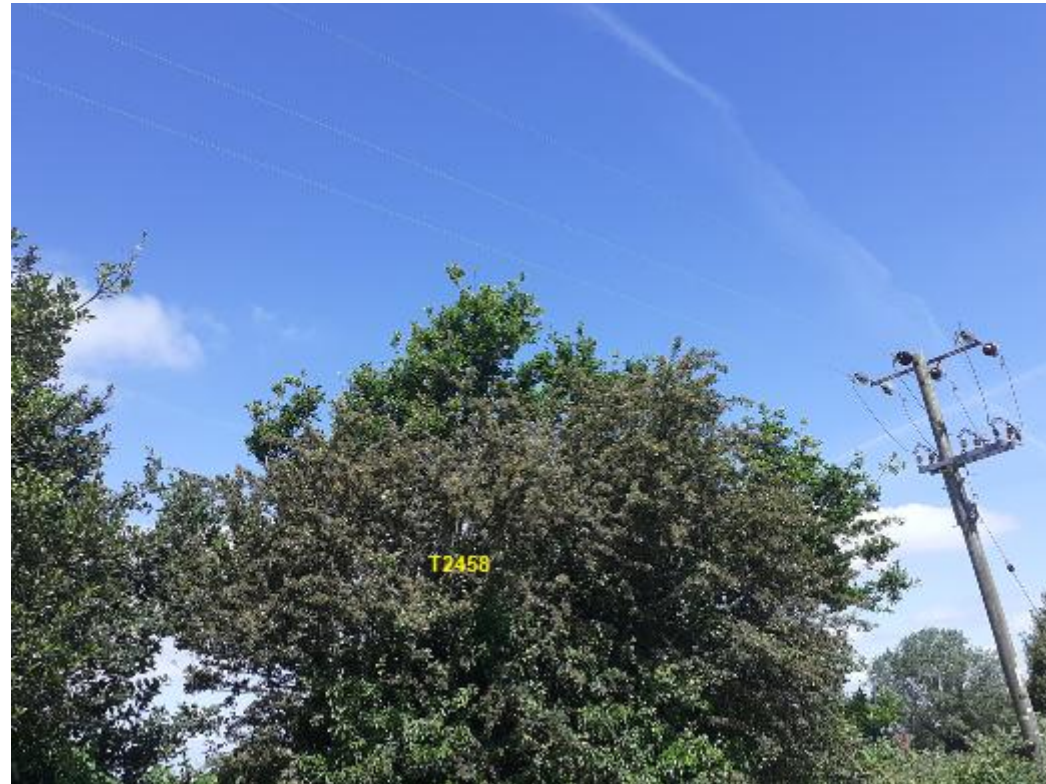
5.2 T2458 & T2460 are within close proximity to the overhead lines, the service provider will usually undertake this work;

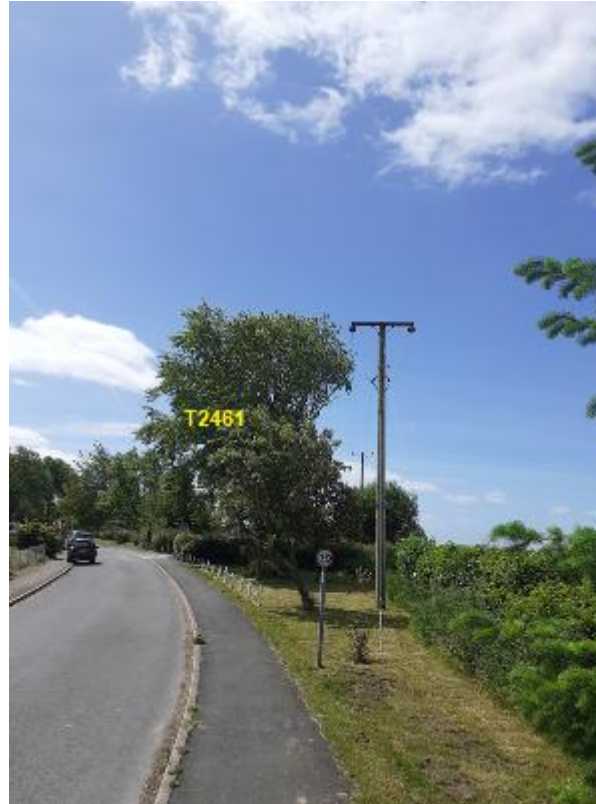
5.3 T2461 is imbalanced due to line clearance;

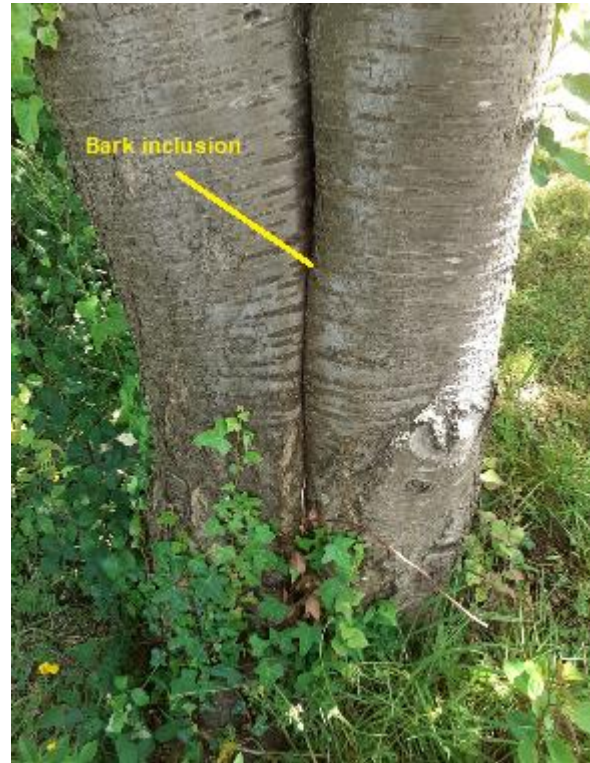
5.4 T2470 requires periodic checks in case the branch union opens up as the 2 stems increase in diameter with incremental growth;

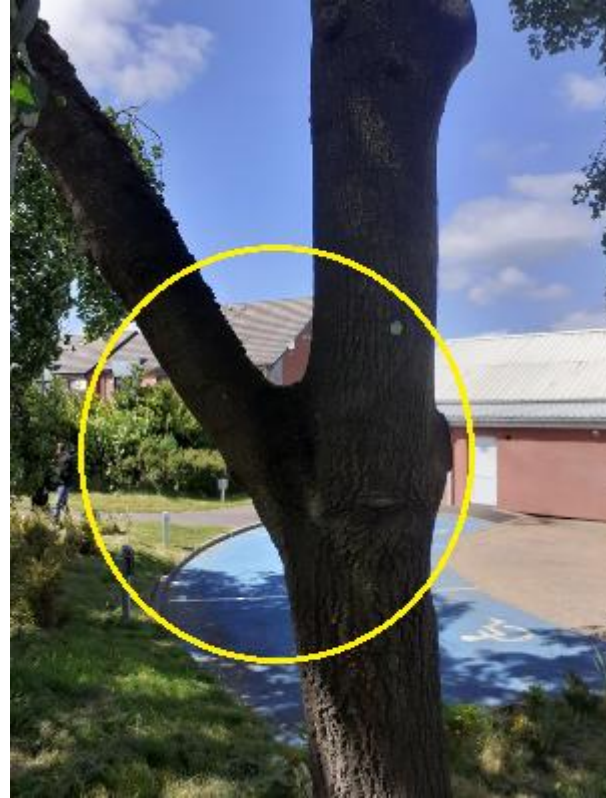
5.5 T2477 would benefit from a bracing system to tether the limb overhanging Woodbury Close;
