Ref Tree Condition Survey Waresley Recreation Ground

Tree Condition Survey

Name of Estate: Hartlebury Village Green

Inspection of trees at Waresley Recreation Ground. DY11 7TL

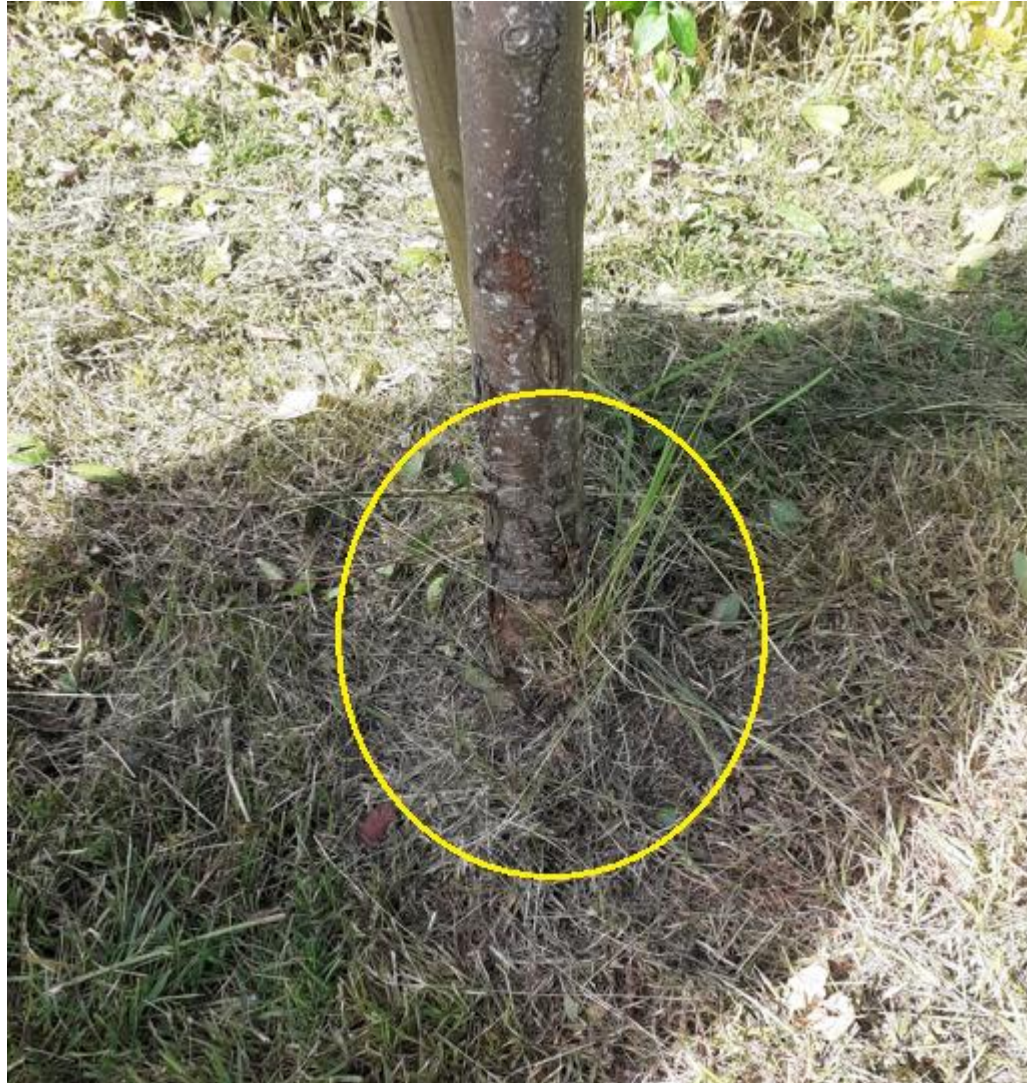
- 5.1 Many trees have bark damage around the basal area from strimmer line this can destroy the tree in time. Using either light strimmer chord, herbicide or shears will prevent this damage occurring.

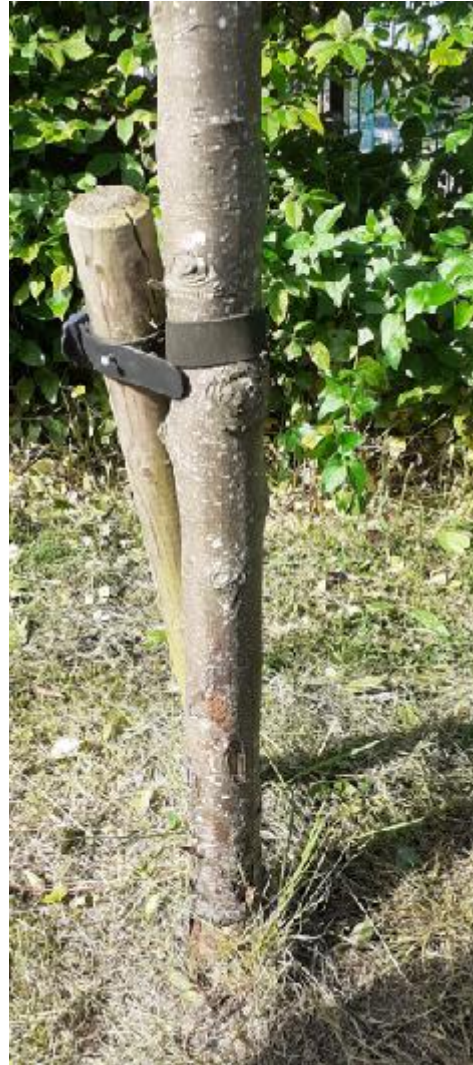
5.2 Many recently planted trees require the stake & tie removing;
