Ref Tree Condition Survey Hartlebury Parish Hall

## Tree Condition Survey

Name of Estate: Hartlebury Parish Hall

Date: 27/05/2022

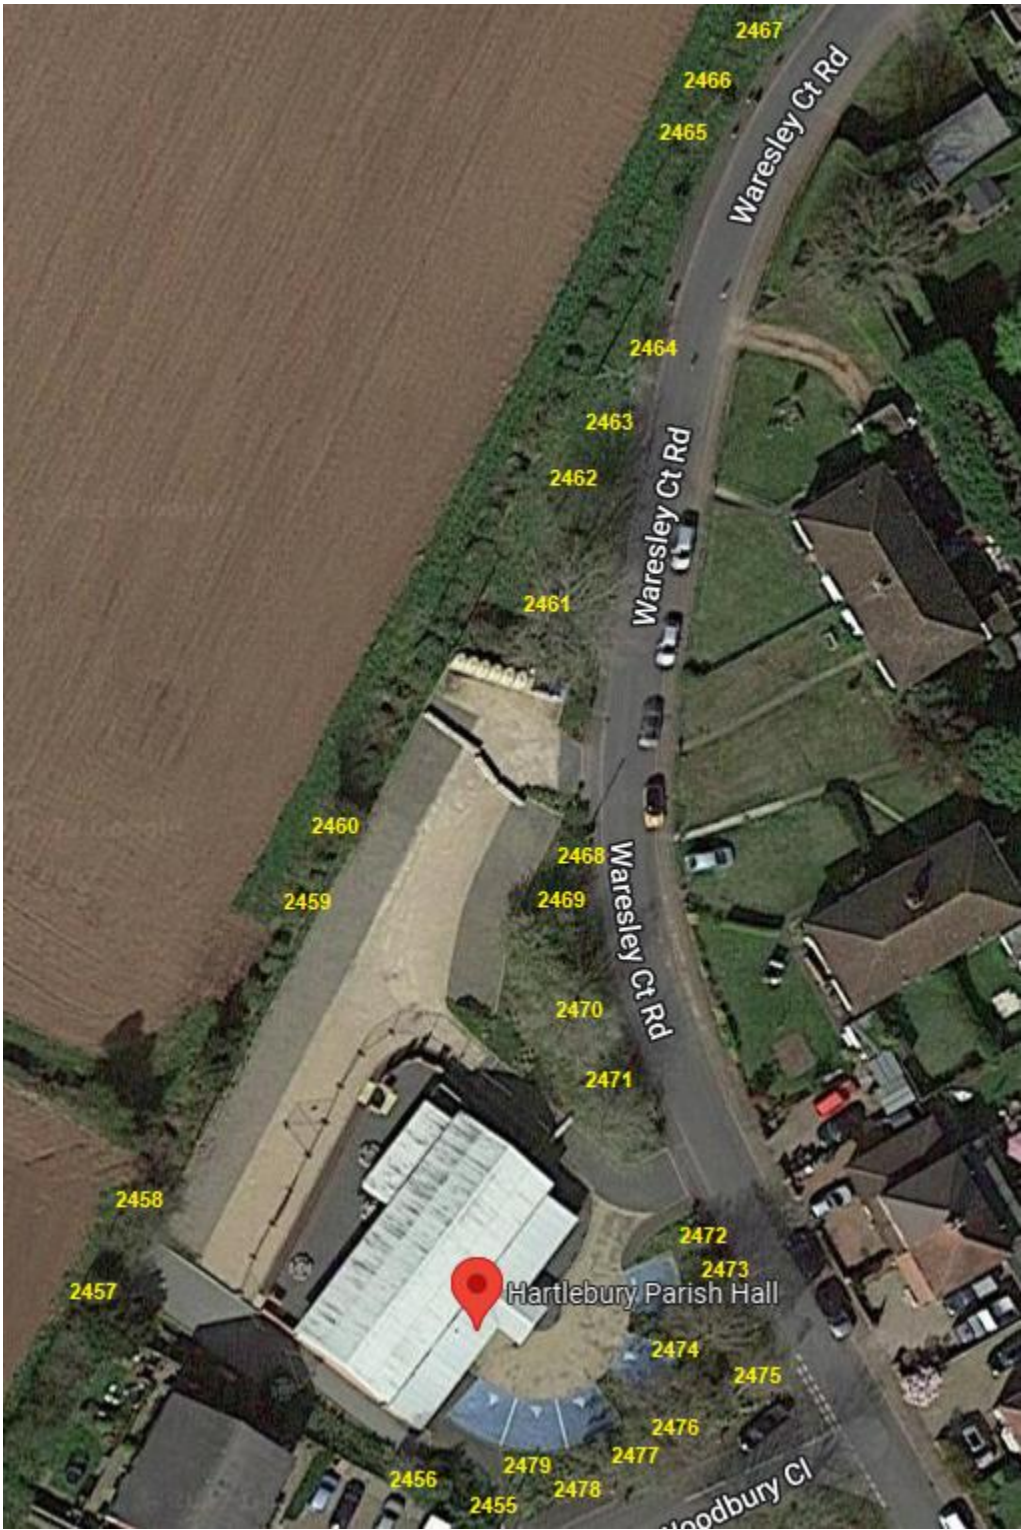
Figure 4 Tree Plan

Tree No.	Common Name	Stems	Height (m)	Stem Dia (mm)	Crown Spread (m)	Age Class	Crown	Stem	Root Zone	Comments & Recommendations	Work Priority
2455	Apple	1	3	30	0.7	Sap	Good	Good	Good	Strimmer damage to base; bark removed; remove tree stake & tie	Low
2456	Wych Elm	1	8	200	3	Dead				Dead; clothed in Ivy - Fell	High
2457	Holly x 2	Ms	6	<250	9	M	Good	Good	Good	On boundary line. Overhead power line 3m directly above; historically maintained clear from French bowls court	Low
2458	Hawthorn, Oak	Ms	<8	<200	8	SM	Good	Good	Good	Trim clear of overhead lines; consult energy provider (Western Power)	Low
2459	Holly x 3	Ms	<5	<180	7	SM	Good	Good	Good	Hedgerow trees	Low
2460	Ash	3	8	<600	7	EM	Good	Good	Good	Historic 4m pollard. In contact with overhead power line; re pollard & sever Ivy @ base	High
2461	Silver Leaved Maple	1	15	490	12	M	Good	Good	Good	Imbalanced canopy due to historic pruning clear from overhead lines	Low

2462	Swedish Whitebeam	1	7	180	5	M	Good	Good	Good	Historic crown lifts with callusing	Low
2463	Swedish Whitebeam	1	7	200	5	M	Good	Good	Good	Historic crown lifts with callusing	Low
2464	Swedish Whitebeam	2	5	140 130	4	M	Good	Mod	Good	Historic crown lifts with good callusing. Leaning habit with co dominant stems. Remove self-set Hawthorn from base	Low
2465	Sitka Spruce	1	5	60	2	Y	Good	Good	Good		Low
2466	Sitka Spruce	1	2.4	30	1.5	Y	Good	Good	Mod		Low
2467	Plum x 2	1	3	<70	5	EM	Good	Good	Good	Historic crown lifts with callusing. Some wounds were flush cut with poor callusing.	Low
2468	Prunus sp.	Ms	8	<190	10	M	Good	Good	Good	Clear basal epicormic growth & sever Ivy	Low
2469	Silver Leaved Maple	1	14	490	10	M	Good	Good	Good	Nest box @ 4m S. minor dead wood, epicormic regrowth from previous pruning points in lower canopy	Low
2470	Wild Cherry	2	12	280 190	10	M	Good	Mod	Good	V shaped union with bark inclusion @ basal area to monitor	Low

2471	Rowan	3	5	70 90	4	EM	Mod	Mod	Good	Leaning habit, isolated decay pockets arising from historic pruning. Basal area bottle butting due to fibre buckling	Low
2472	Lilac	Ms	4	<150	5	M	Mod	Mod	Mod	Multi stemmed coppice, dense Ivy to sever @ base & clean of dead wood	Low
2473	Wild Cherry	1	6	210	6	EM	Good	Good	Good	Sever Ivy @ base	Low
2474	Aspen	1	14	250	9	EM	Good	Good	Good	Historic crown lifts with callusing; Sever Ivy @ base	Low
2475	Aspen	1	15	210	7	EM	Good	Good	Good	Imbalanced canopy, very sparse inner canopy. Many limbs are end loaded with foliage (lion's tail) which have a slight risk of tearing; monitor	Low
2476	Wild Cherry	1	7	140	4.5	SM	Mod	Good	Good	Lift crown 2.4m over footpath on Woodbury Close	Low

2477	Aspen	1	15	330	9	EM	Good	Good	Good	Historic crown lifts have created isolated decay pockets in stem. Section of chord around stem to remove @ 3m S. V shaped union to brace because 1 stem which overhangs Woodbury Close could potentially fail	Med
2478	Aspen	1	7	160	5	SM	Good	Good	Good	Canopy imbalance towards S.	Low
2479	Himalayan Birch	3	3	20	1	Sap	Good	Good	Good	Multi stemmed, 2 weaker stems to be removed; remove tree stake & tie	Med
