Ref Tree Condition Survey Waresley Recreation Ground

Tree Condition Survey

Name of Estate: Hartlebury Village Green

Inspection of trees at Waresley Recreation Ground. DY11 7TL

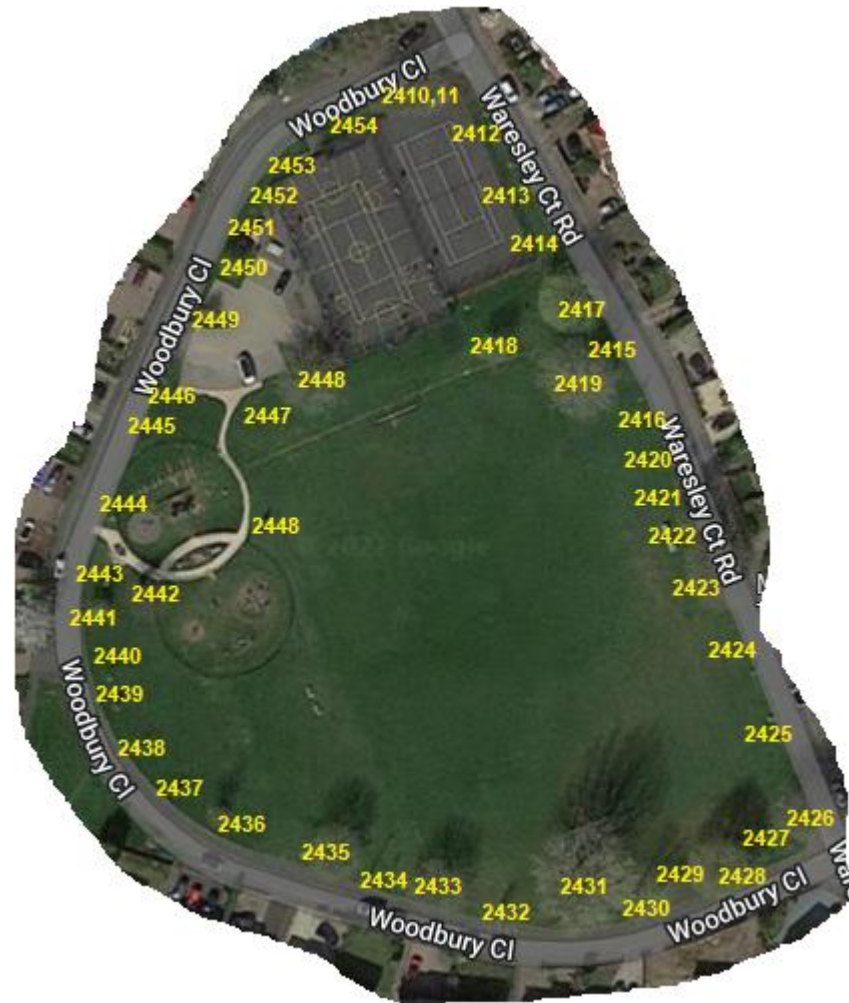
Figure 4 Tree Plan

Tree No.	Common Name	Stems	Height (m)	Stem Dia (mm)	Crown Spread (m)	Age Class	Crown	Stem	Root Zone	Comments & Recommendations	Work Priority
2410	Purple Norway Maple	1	12	330	9	M	Good	Good	Good	Crown die back W. 2-7m, bifurcates @2.4m, historic 7m pollard with some arising dead wood around this pruning zone in centre, remove rope from stems @ 3m N. to prevent girdling	Low
2411	Purple Norway Maple	1	12	430	9	M	Good	Good	Good	Bifurcates @ 2.4m, historic 7m pollard, live nest box @ 3m. Clean of minor dead wood	Low
2412	Crab Apple	1	4	50	1	Sap	Good	Good	Mod	Strimmer damage to base; bark removed; remove tree stake & tie	Low
2413	Crab Apple	1	4	50	1	Sap	Good	Good	Good	Strimmer damage to base; bark removed; remove tree stake & tie	Low
2414	Crab Apple	1	4	50	1	Sap	Good	Good	Good	Strimmer damage to base; bark removed; remove tree stake & tie	Low
2415	Crab Apple	1	4	50	1	Sap	Good	Good	Good	Strimmer damage to base; bark removed; remove tree stake & tie	Low

2416	Crab Apple	1	4	50	1	Sap	Good	Good	Good	Strimmer damage to base; bark removed; remove tree stake & tie	Low
2417	Norway Maple	1	11	410	10	M	Good	Good	Good	Historic 7m pollard with regrowth, nest box, minor dead wood; 2.4m crown lift	Low
2418	Norway Maple	2	9	340	6	M	Good	Mod	Good	Clean of minor dead wood; decay in stem with good reaction wood	Low
2419	London Plane	1	12	500	11	M	Good	Good	Good	Historic crown lifts with good callusing. 2.4m crown lift	Low
2420	Wellingtonia	1	3	90	1.5	SM	Good	Good	Good	Strimmer damage to base	Low
2421	Malus sp.	1	4	150	2.5	M	Mod	Mod	Mod	Historic vehicle damage with torn limb canopy now imbalanced with poor vigour	Low
2422	Swedish Birch	1	15	300	8	M	Good	Mod	Good	Historic lifts with callusing, strimmer damage to base with decay pocket @ 1.2m N. with good surrounding reaction wood. Minor dead wood.	Low
2423	Yoshino Cherry	1	11	660	15	LM	Good	Good	Good	Historic crown lifts & pruning over roadside to form imbalanced canopy. Minor dead wood throughout canopy, isolated decay pocket @ 3m E., elevated root plate.	Low

2424	Coast Redwood	1	2.4	40	1.2	Sap	Good	Good	Good	Recently planted tree starting to establish itself; remove tree stake & tie from base	Low
2425	Ash	2	4	50 50	1.5	Sap	Mod	Mod	Mod	Poor V shaped union @ base, crown die back to monitor, strimmer damage to base; remove tree stake and tie & monitor condition	Low
2426	Yoshino Cherry	1	10	850	12	LM	Mod	Mod	Good	Elevated root plate with minor roots girdling. V shaped union in stem as a consequence heavy limb on W. has been supported by 3 cobra braces. Canopy imbalance due to historic pruning over highway	Low
2427	Coast Redwood	1	2	25	1.5	Sap	Good	Good	Good		Low
2428	Norway Maple	1	12	450	12	M	Good	Good	Good	Historic lifts with callusing; low canopy requires 2.4m crown lift over park & 5m lift over highway	Med
2429	English Oak	1	5	110	4	Y	Good	Good	Good	Strimmer damage to base & suppressed by adjacent trees	Low
2430	London Plane	1	10	270	8	SM	Good	Good	Good	Historic crown lifts with callusing	Low

2431	Black Poplar	1	23	1020	16	M	Mod	Good	Good	Historic crown reduction with 7m re growth now exerting lever arm stresses on old wounds. 5m crown reduction above previous pruning points recommended	Med
2432	Birch sp.	1	4.5	80	1.5	Y	Good	Good	Good	Remove tree stake	Low
2433	Ash	1	9	340	8	SM	Good	Good	Good	Historic crown lifts with callusing	Low
2434	English Oak	1	4.5	50	1.5	Sap	Good	Good	Good	Strimmer damage to base; bark removed; remove tree stake & tie	Low
2435	Ash	1	9	300	9	SM	Good	Good	Good	Historic crown lifts with callusing	Low
2436	Birch sp.	1	8	140	5	SM	Good	Good	Good	2m crown lift	Low
2437	Beech	1	3.5	100	2.4	Y	Good	Good	Good	Dense growth habit, remove tree stake	Low
2438	English Oak	1	4.5	60	1.8	Y	Good	Good	Good	Strimmer damage to base; bark removed; remove tree stake & tie	Low
2439	Beech	1	4	60	2	Y	Good	Good	Good	Historic crown lifts some cuts flush. Strimmer damage to base; bark removed; remove tree stake & tie	Low

2440	Crab Apple	1	3.5	40	1	Sap	Good	Good	Good	Strimmer damage to base; bark removed; remove tree stake & tie	Low
2441	Swedish Birch	1	10	200	5	SM	Good	Good	Good	Weeping habit; 2m crown lift	Low
2442	English Oak	1	8	1060	7	Vet	Mod	Mod	Mod	Historic monolith on veteran, some vigorous regrowth to S. Monitor for basal movement	Low
2443	Crab Apple	1	4	50	1	Sap	Good	Good	Good	Strimmer damage to base; bark removed; remove tree stake & tie	Med
2444	Crab Apple	1	4	50	1	Sap	Good	Good	Good	Strimmer damage to base; bark removed; remove tree stake & tie	Low
2445	Whitebeam	1	4	50	1	Sap	Good	Good	Good	Strimmer damage to base; bark removed; remove tree stake & tie	Low
2446	Whitebeam	1	4	50	1	Sap	Good	Good	Good	Strimmer damage to base; bark removed; remove tree stake & tie	Low
2447	Whitebeam	1	3	50	1	Sap	Good	Good	Good	Strimmer damage to base; bark removed; remove tree stake & tie	Low
2448	Holly Oak	1	3.5	70	1.5	Y	Good	Good	Good	Strimmer damage to base; bark removed; remove tree stake & tie	Low

2449	Japanese Cherry 'Kanzan'	1	8	660	10	M	Good	Good	Good	Nest box - live, remove hung up flag @ 4m S., Clean of minor dead wood & 2.4m crown lift; bacterial canker present in stem	Low
2450	English Oak	1	4.5	150	4	Y	Good	Good	Good	0.5m crown lift	Low
2451	Birch sp.	2	8	150 100	5	SM	Good	Mod	Good	V shaped union @ 1m with bark inclusion; historic lifts with callusing. 2.4m crown lift & head back weaker, leaning stem <1.5m	Low
2452	Whitebeam	1	4	50	1.5	Y	Good	Good	Good	Remove tree stake & tie	Low
2453	Whitebeam	1	4	50	1.5	Y	Good	Good	Good	Strimmer damage to base; bark removed; remove tree tie from base	Low
2454	Whitebeam	1	4	50	1	Sap	Good	Good	Good	Strimmer damage to base; bark removed; remove tree tie from base	Low

- 5.1 Many trees have bark damage around the basal area from strimmer line this can destroy the tree in time. Using either light strimmer chord, herbicide or shears will prevent this damage occurring.
